Wirestrike and collision with terrain involving Schweizer 269C, VH-NTZ

Deloraine, Tasmania, 20 July 2016

ATSB Transport Safety Report
Aviation Occurrence Investigation
AO-2016-081
Final – 28 September 2016

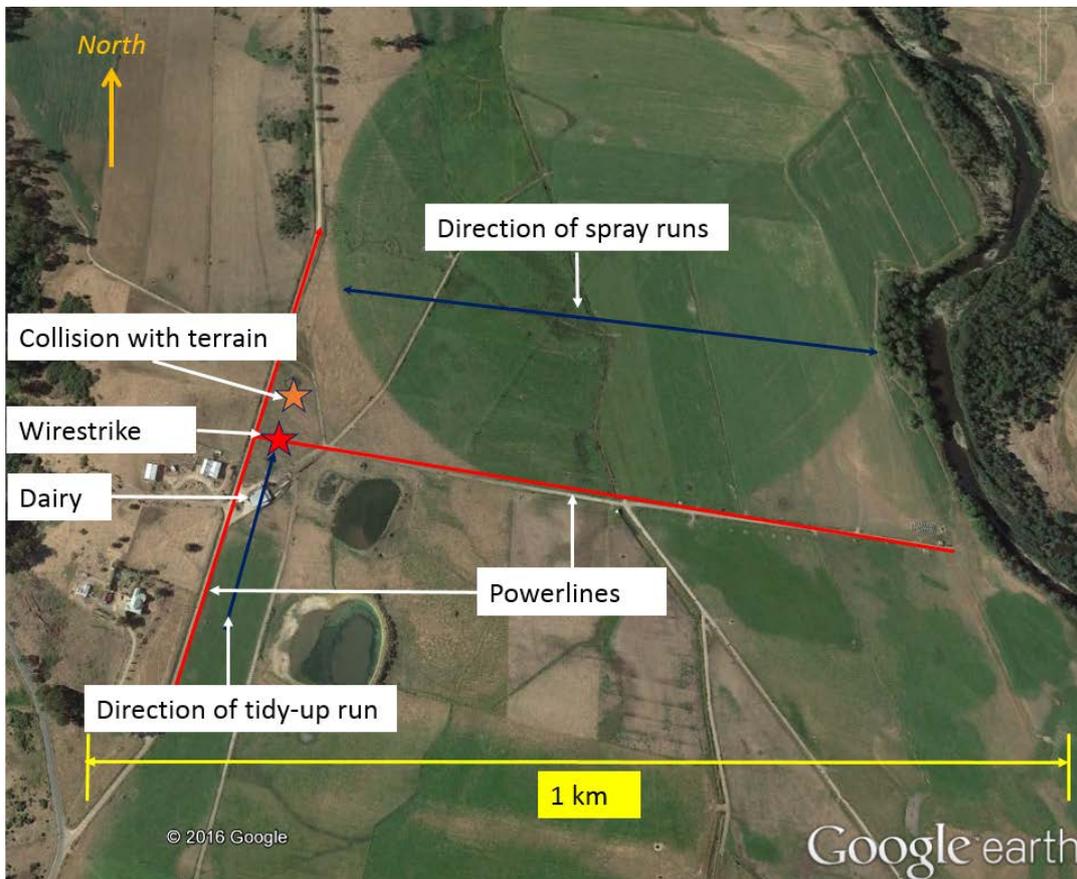
Figure 1: Area of operations showing powerlines

The pilot completed spraying one area, and prior to commencing spraying another, overflew it to assess the site. During that inspection, the pilot sighted two sets of powerlines, one running approximately north-south, and the other branching off to the east. Based on the location of the powerlines and the wind, which was a light northerly, the pilot elected to spray the paddock in an east-west direction (Figure 1). The helicopter was operating north of the powerline running east-west, and in each run, was overflying and remaining clear of the powerlines at the western end of the paddock.

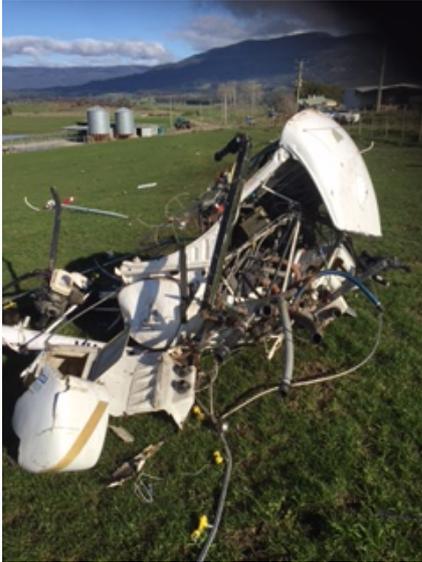
Figure 2: Accident site

After overflying a dairy building, the helicopter descended as the pilot intended to commence spraying. However, the helicopter struck the powerlines running east-west and subsequently collided with terrain.

The pilot, who was the sole occupant of the helicopter, sustained serious injuries and the helicopter was destroyed (Figure 2).
